# Navajo Abandoned Uranium Mine

## **Site Screen Report**

## Captain Benally No. 4A AUM Site

August 2010

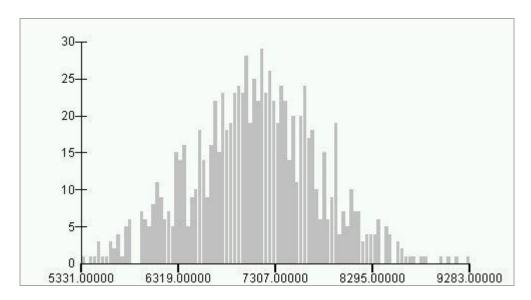
The following chart and statistics were generated by ESRI ArcGIS 9.3.1, and show the general distribution of the site gamma radiation measurements. The horizontal X axis represents the gamma radiation reading levels in cpm (lowest levels to the left). The vertical Y axis represents the frequency of each gamma radiation level.

Count:	918	
Minimum:	5331.00000	
Maximum:	9283.00000	
Sum:	6523484.00000	
Mean:	7106.19172	
Median:	7111.50000	
Standard Deviation:	644.78358

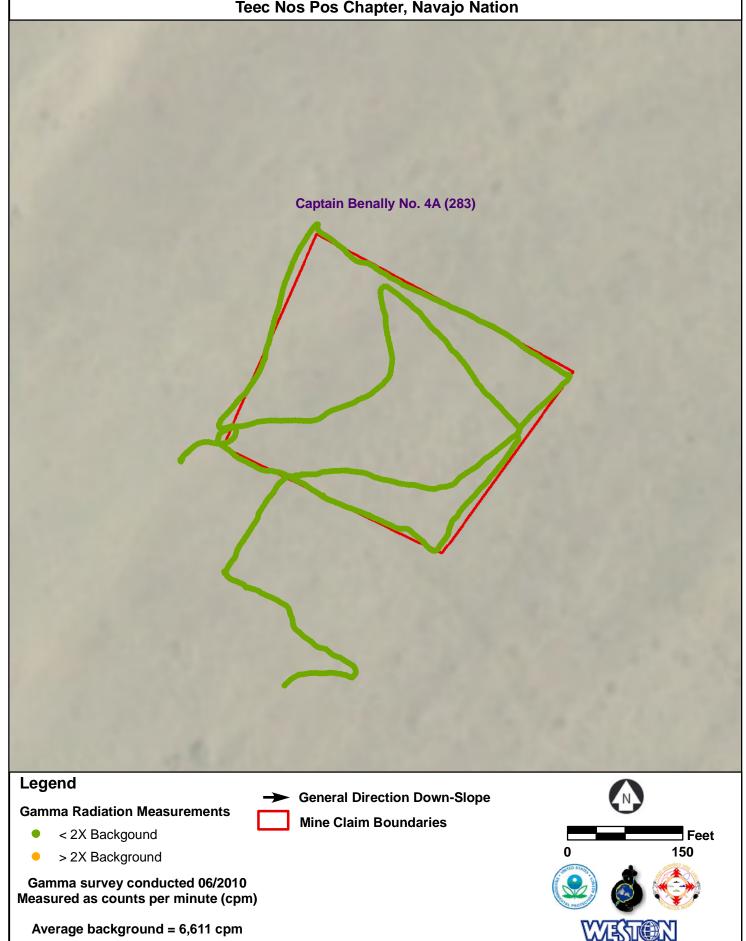
Figure 1 - Gamma Radiation Measurements, Above Two Times Background
Captain Benally No. 4A (283)
Teec Nos Pos Chapter, Navajo Nation

A total of 918 gamma radiation measurements were collected from the mine site, ranging from 5,331 cpm to 9,282 cpm. The measurements are represented in Figures 1 and 2.

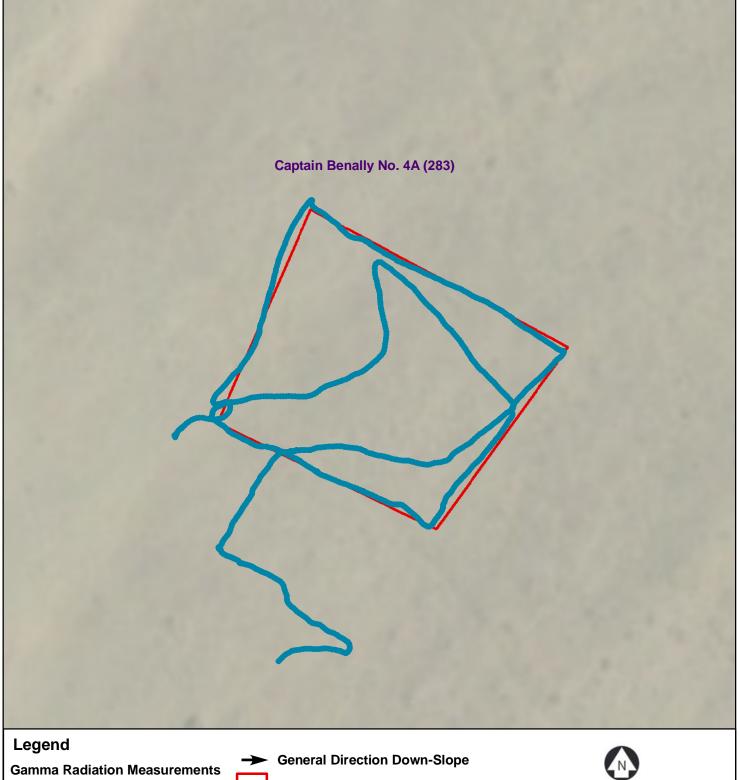
**Figure 2 - Gamma Radiation Measurements** Captain Benally No. 4A (283) Teec Nos Pos Chapter, Navajo Nation

Gamma survey conducted 06/2010 Measured as counts per minute (cpm)

Average background 6,611cpm
